WALTHER SIDEWALK GEOMORPHOLOGY AND PHASE I ARCHAEOLOGICAL SURVEY

**New Castle County, Delaware
Walther Sidewalk Project
Geomorphology and Phase I Archaeological Survey
Management Summary**

**Christopher T. Espenshade,
Principal Investigator
and
Barbara J. Gundy**

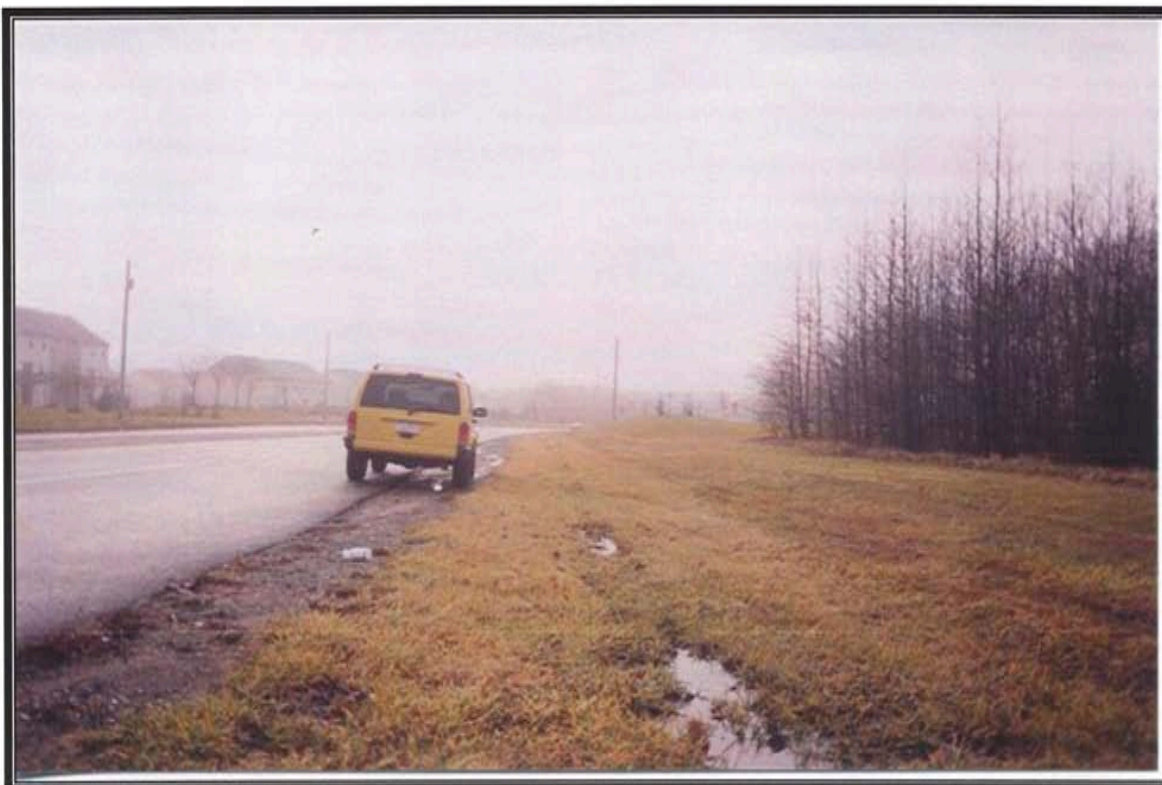
Photograph A-1. General view of northern terminus of project APE, facing south. Note the graded area adjacent to the roadway.

Most areas exhibited such obvious prior excavation that no soil sampling was necessary (Photographs A-1, A-2, and A-3). Auger borings were taken within the areas which appeared to be less disturbed or intact. It was determined that only one portion of the project APE was not disturbed and was suitable for archaeological testing (Photograph A-4). Auger Borings 1 and 2, taken in two disturbed areas (Appendix A-1), were comprised of a truncated profile of Coastal Plain sediment (Figure A-3). Only the lower subsoil of the original soil remained intact. No testing was recommended within areas exhibiting this type of truncated stratigraphic profile.

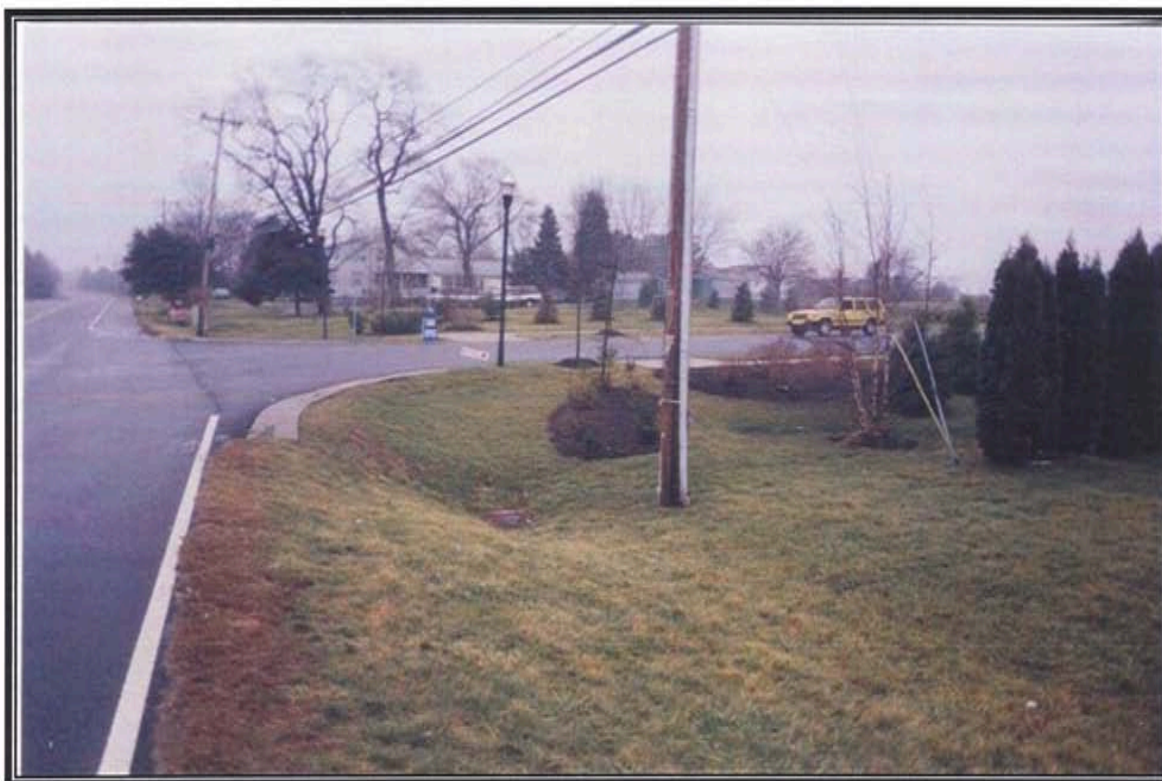
Photograph A-2. General view of central portion of project APE near Glennwood, facing south. Note existing curbs, utilities, drainage swales, and drainage stormwater grate.

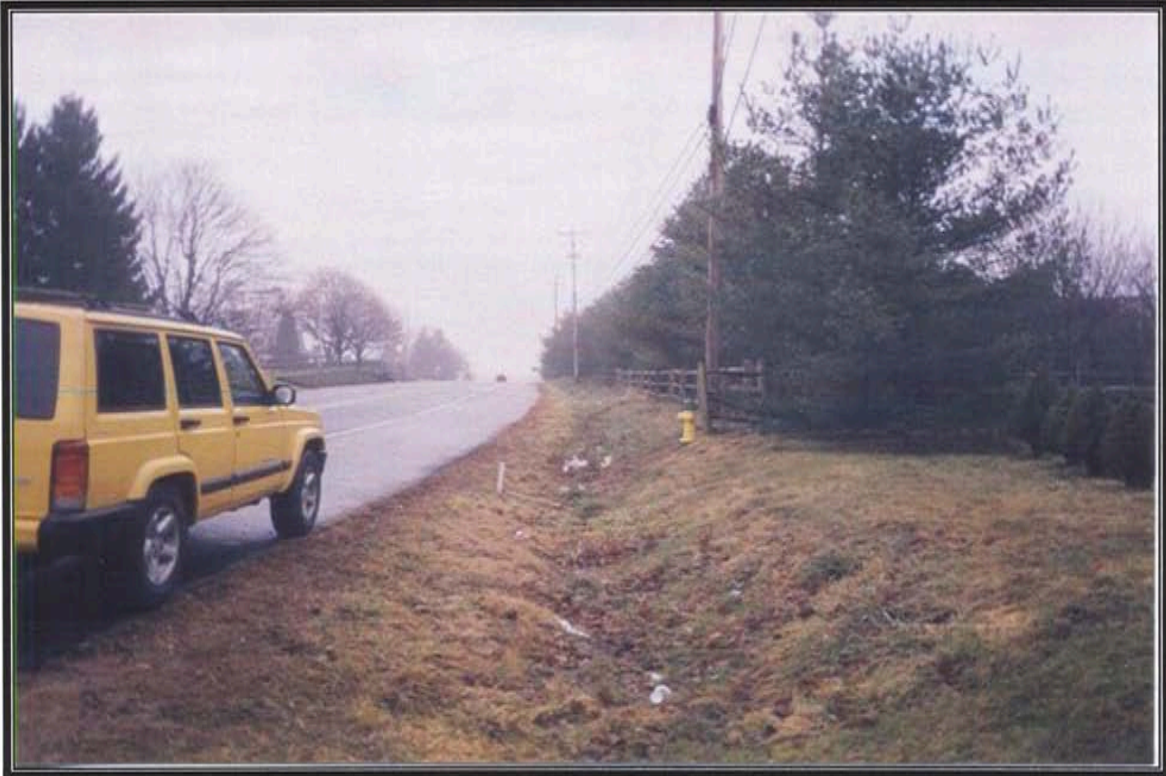
Photograph A-3. General view of central portion of project APE, north of Creekside Drive, facing south. Note fire hydrant, buried water lines, utilities, drainage swale, fencing, and landscaping with large conifers.

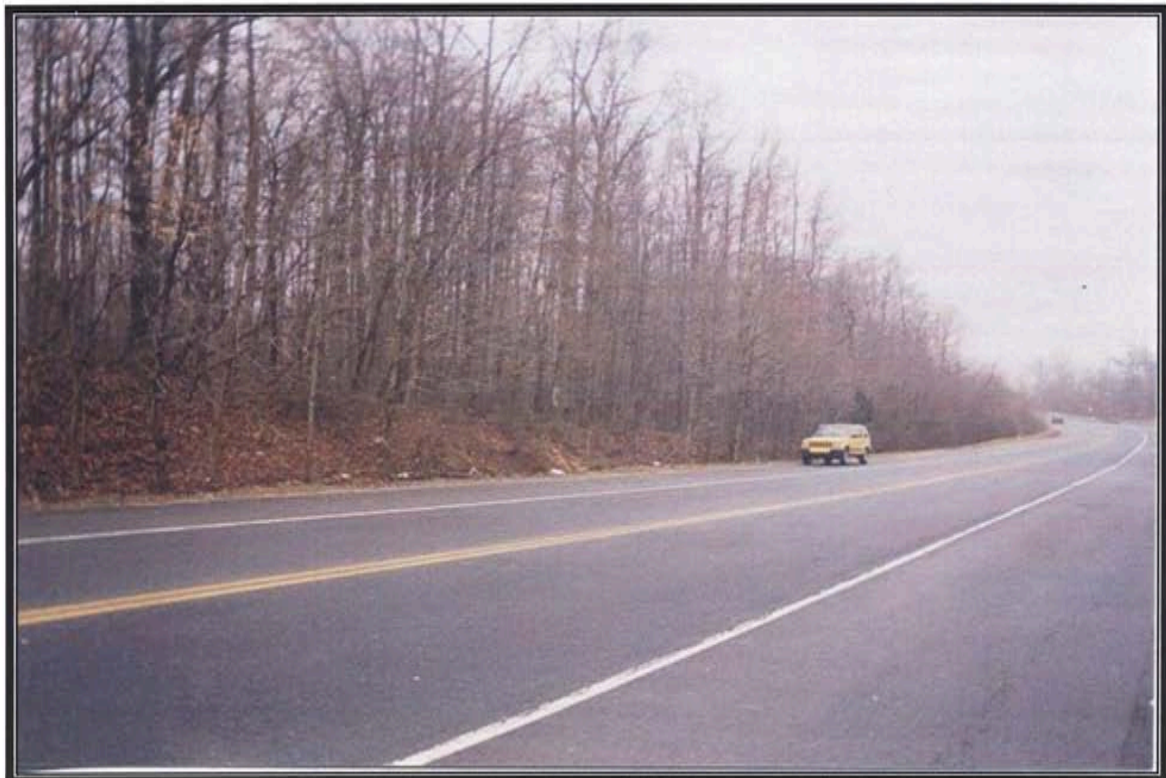
Photograph A-4. General view of portion of APE near southern terminus that was not disturbed and was surveyed.

The auger boring taken within the undisturbed portion of the project APE was comprised of a relatively intact soil. Three STPs were excavated within this area, and the stratigraphic profile of STP N100 E100 was examined and described (Figure A-4; Appendix A-1). This profile was comprised of a well developed profile forming in Coastal Plain sediment, with a plowed surface (Ap horizon) and deeply weathered subsoil (Bt horizon). No cultural materials were recovered from any of the three STPs.

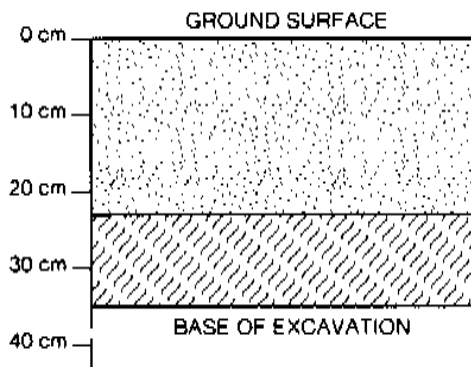
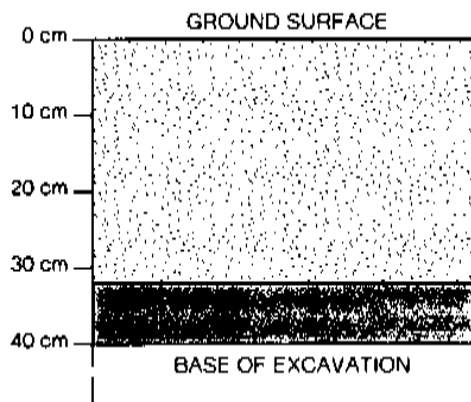
FIGURE A-3

SOIL PROFILE AUGER BORING 1

C 10YR 5/3 Brown loam

2BC 10YR 5/4 Yellowish brown sandy loam, with few
10YR 5/6 Yellowish brown mottles

SOIL PROFILE AUGER BORING 2

2BC 10YR 5/4 Yellowish brown sandy loam, with 10%
fine gravels and 10YR 5/6 Yellowish brown
mottles

SOIL PROFILES
AUGER BORINGS 1 AND 2

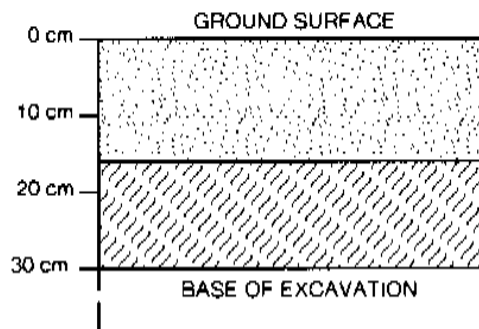
FIGURE A-4

SOIL PROFILE SHOVEL TEST PIT N100 E100

Ap 10YR 3/2 Very dark grayish brown gravelly loam,
with 20% gravels

Bt 10YR 5/4 Yellowish brown very gravelly clay loam,
with 60% gravels

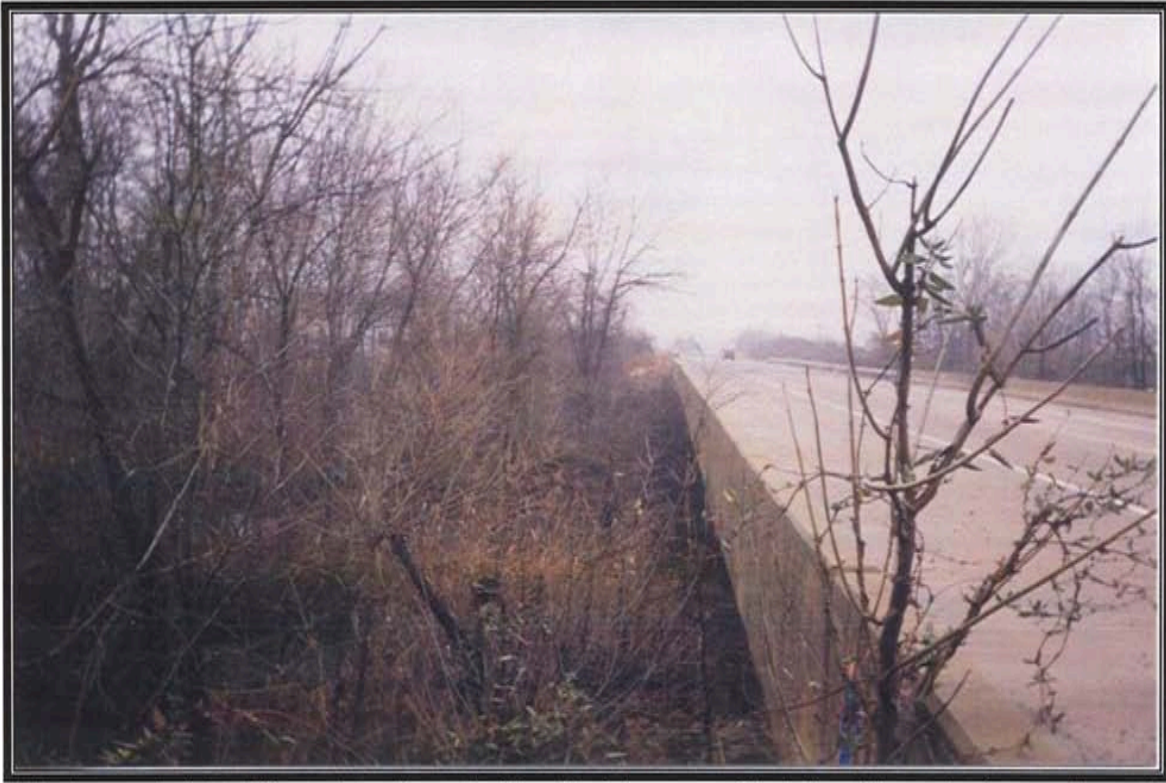
Photograph A-5. View of northeast side of bridge over Christina River, facing northwest.

The Christina River, a much larger stream, flows west to east within the southern portion of the APE, toward its confluence with the Delaware River approximately 24.0 km (14.9 mi) downstream (Photographs A-5 and A-6). The proposed sidewalk construction does not affect any portion of this river valley. The proposed project involves construction on only the bridge deck, and does not extend onto the hillsides or floodplain of the river.

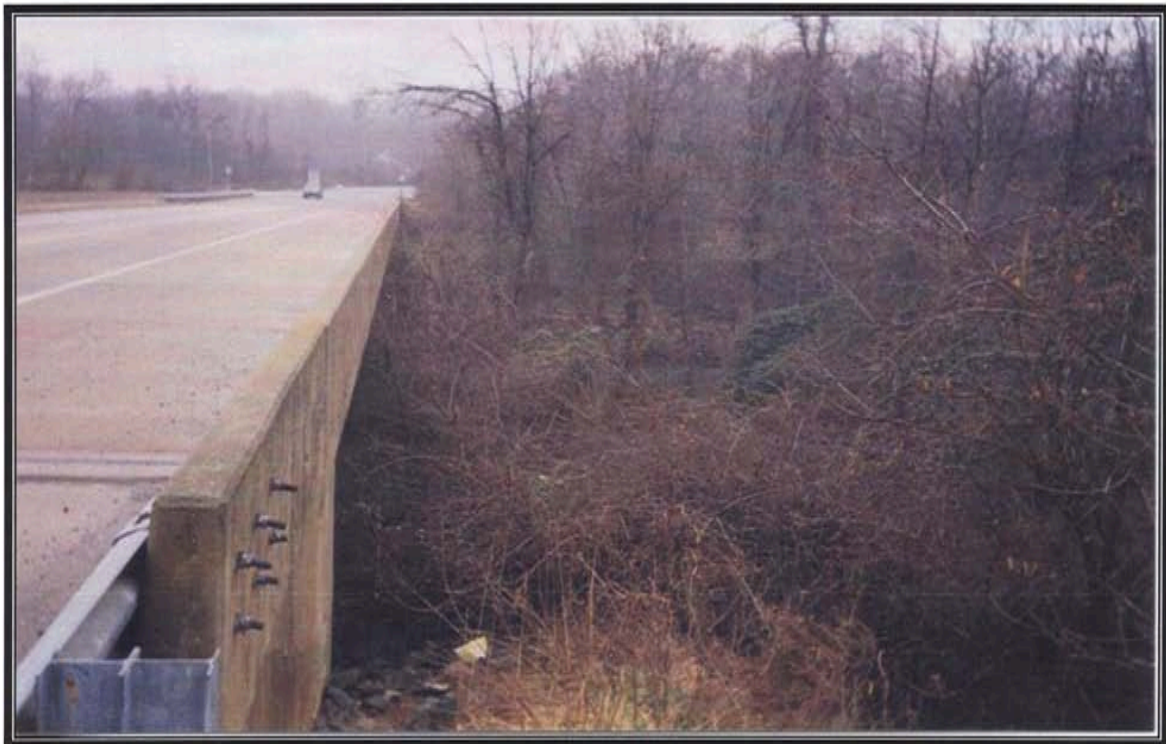
Photograph A-6. View of northeast side of bridge over Christina River, facing southeast.
